Du Vin Restaurant

Commercial Dishwasher Field Test

Location:	<i>Honolulu, Hawaii - USA</i> <i>[Installation performed by Nano Tek-On]</i>	First Inspection:	<i>After 1 month</i>
Application:	<i>Commercial Dishwasher</i>	Second Inspection:	<i>After 6 months</i>
Purpose of Installation:	<i>Remove existing limescale deposits and inhibit new limescale accumulation</i>		
Installation Date:	<i>February 16, 2011</i>

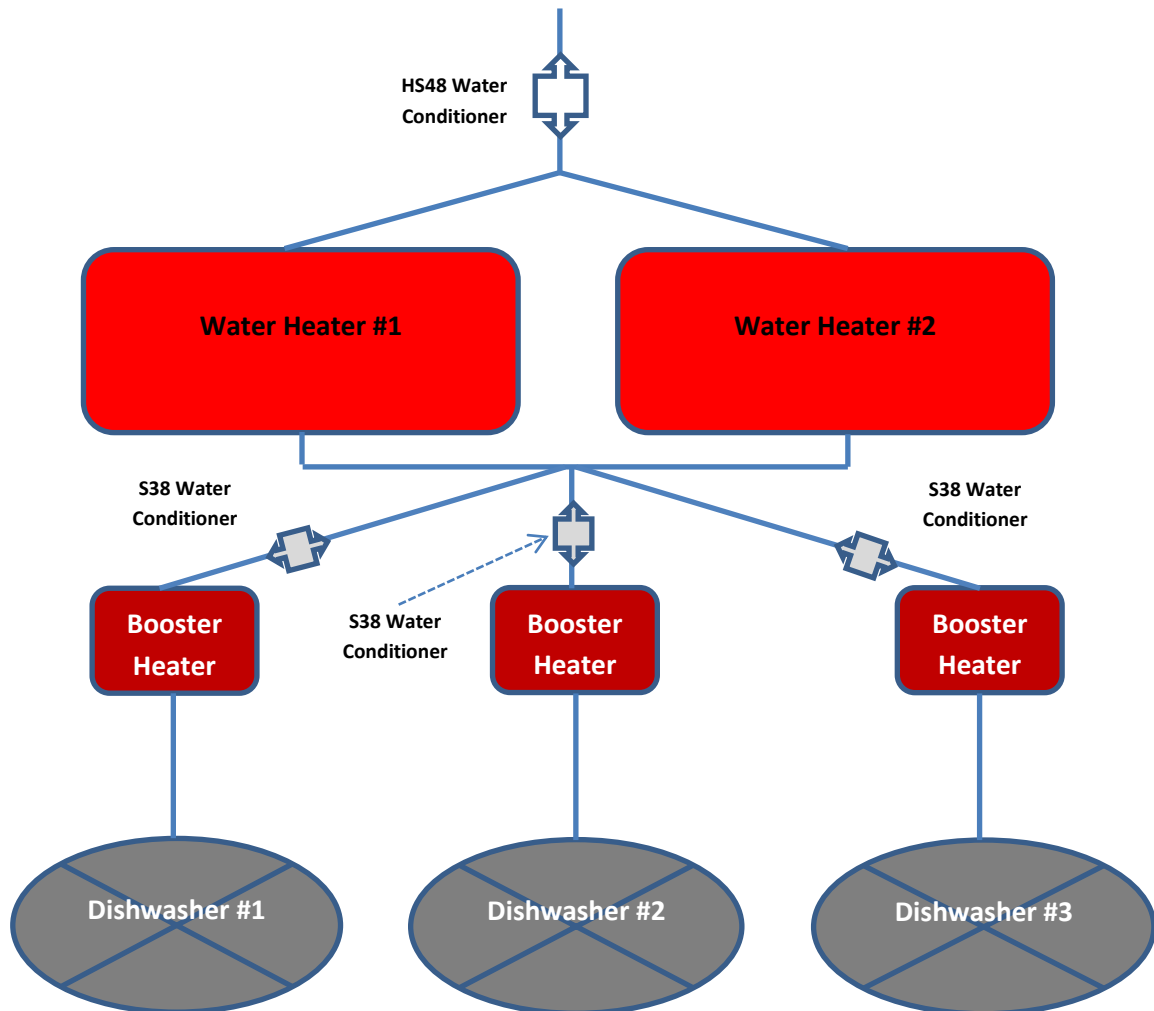
Recommended Installation Location

Model of Water conditioner	S38 (Fits pipes up to 1.5")
Pipe Diameter (OD)	3/4"
Pipe Material	Metal
Installation location	Incoming water line to the dishwasher

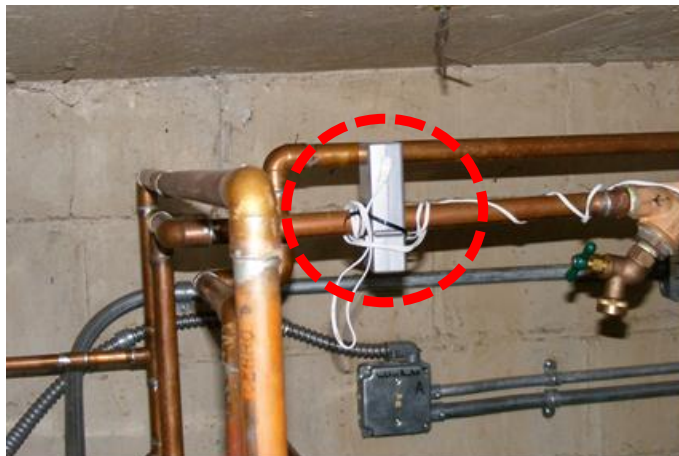
Installed S38 water conditioner

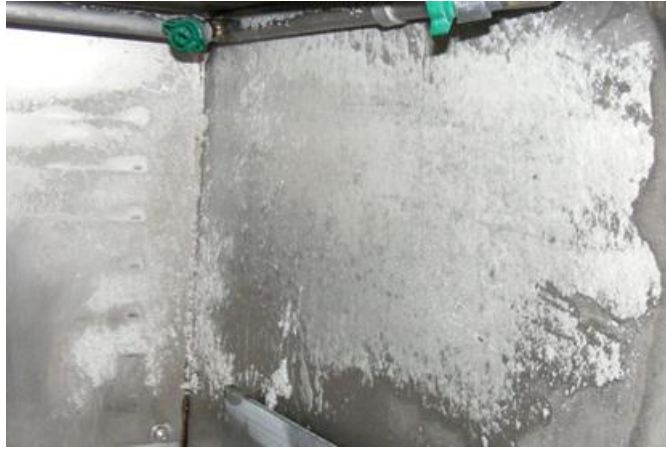
In addition to standard limescale accumulation on all faucets, the restaurant's 3 dishwashers suffer from severe limescale accumulation that shortens their life cycle, cause waste of electricity, require constant maintenance and cause spotting on glassware and silverware.

Prior to installation

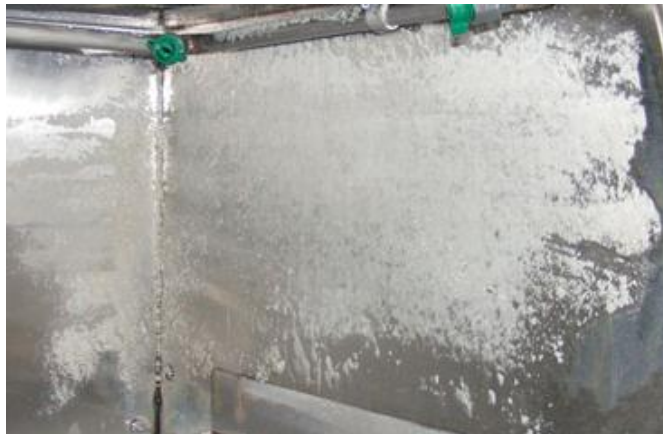
1 month after installation

- Limescale immediately stopped accumulating on the faucet heads and inside the dishwashers.
- Limescale deposits gradually began to dissolve overtime, especially after a chemical descaling wash was performed (after the first inspection).
- The 2 standard water heaters and 3 booster water heaters are operating more efficiently.
- Significant spotting reduction on the glassware and silverware was achieved.
- Maintenance costs went down to a minimum.

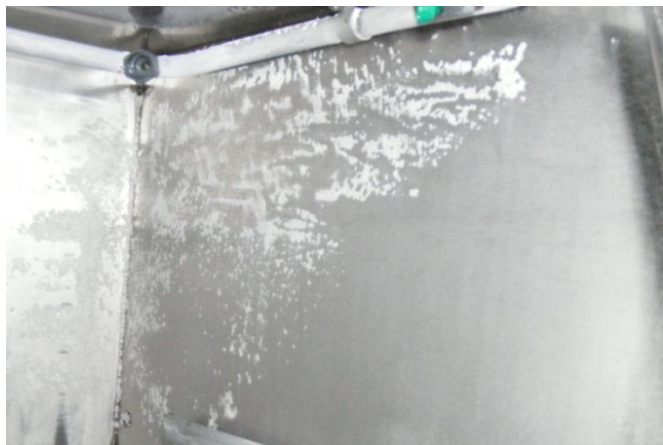
6 months after installation
