Third-Party Technology Verification of the Hydropath Technology at the J. P. Messerly Water Pollution Control Plant, Augusta, Georgia.

PREPARED FOR: Tal Journo/*HydroFLOW* USA LLC (*HydroFLOW* USA)
PREPARED BY: Samuel Jeyanayagam, PhD, PE, WEF Fellow/Jacobs (Jacobs)
DATE: October 12, 2018

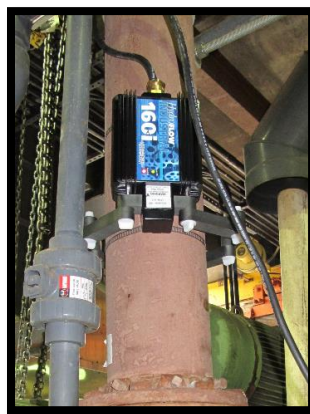
The *HydroFLOW* I Range is powered by the patented Hydropath technology. When properly installed on a pipe (see Figure 1), it induces a 150 kilohertz, oscillating sine wave, alternating current (AC) signal. The electric induction is performed by a special transducer connected to a ring of ferrites. The pipe and the flowing fluid act as a conduit, which allows the signal to propagate. The induced AC signal is believed to cause the mineral ions that make up struvite (magnesium, ammonium, and phosphate) to form loosely held together clusters. When certain conditions are created (e.g., pressure change, temperature change, and turbulence) the clusters precipitate out of solution and form stable crystals of struvite that remain in suspension. The crystals are not able to adhere to surfaces as hard scale and are carried away with the flow. Because hard scale no longer accumulates, the shear forces created by the flowing liquid erode and soften existing scale deposits over time. It is important to note that constant liquid flow is required to remove hard scale deposits from a system.

Figure 1: Installed *HydroFLOW* unit (Model 160i) at a wastewater treatment plant

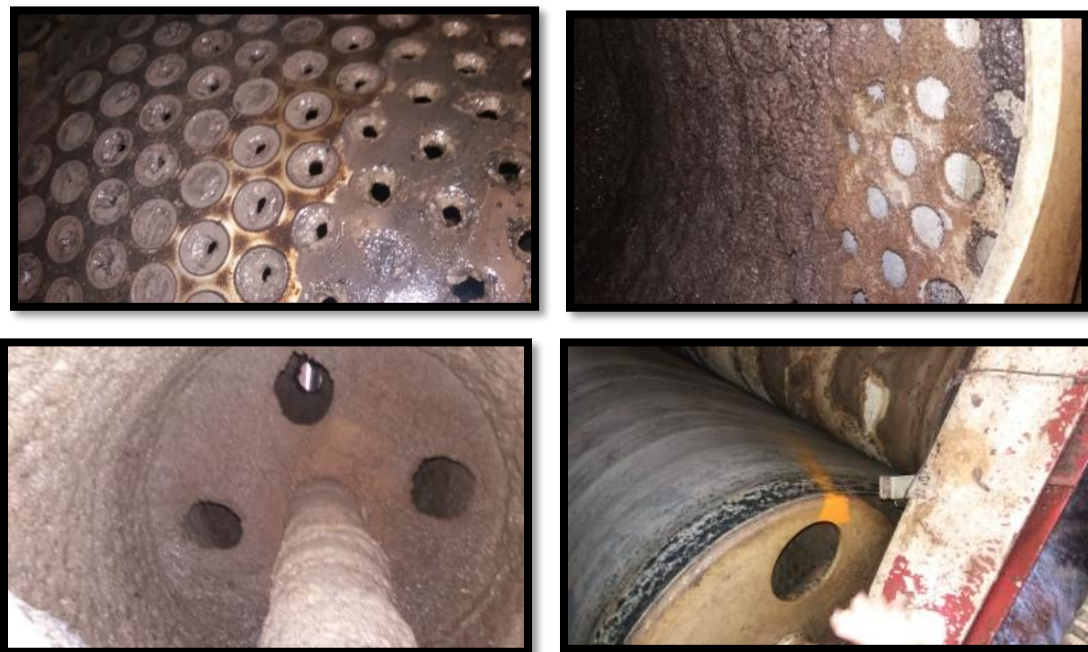
Before energizing the *HydroFLOW* unit, several pictures were taken to establish baseline condition. As shown in the Figure 4 below, heavy struvite encrustation was evident on the drum surface. Other parts of the BFP also showed struvite scale accumulation.

Figure 4: Baseline condition on 7th September 2017 before *HydroFLOW* was activated
