HydroFLOW Case Study - Municipal Building Chillers

Installed: May 2023

Last Inspection: October 2023

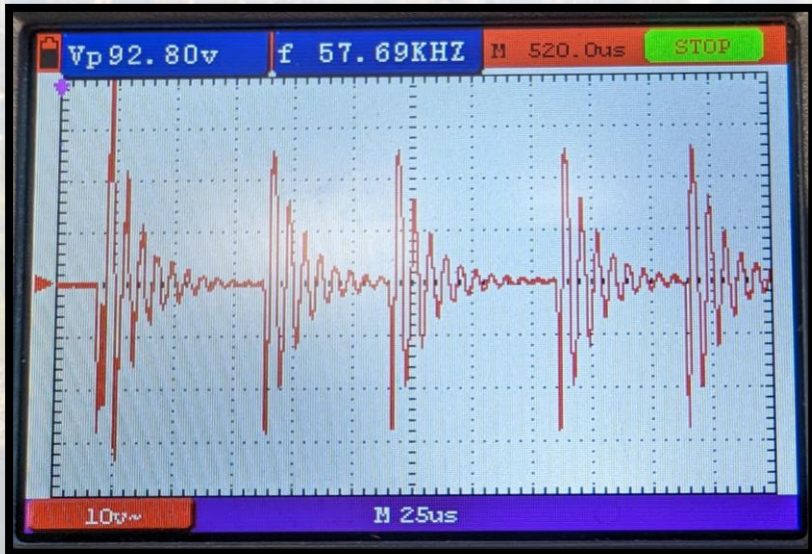
Hydropath Signal

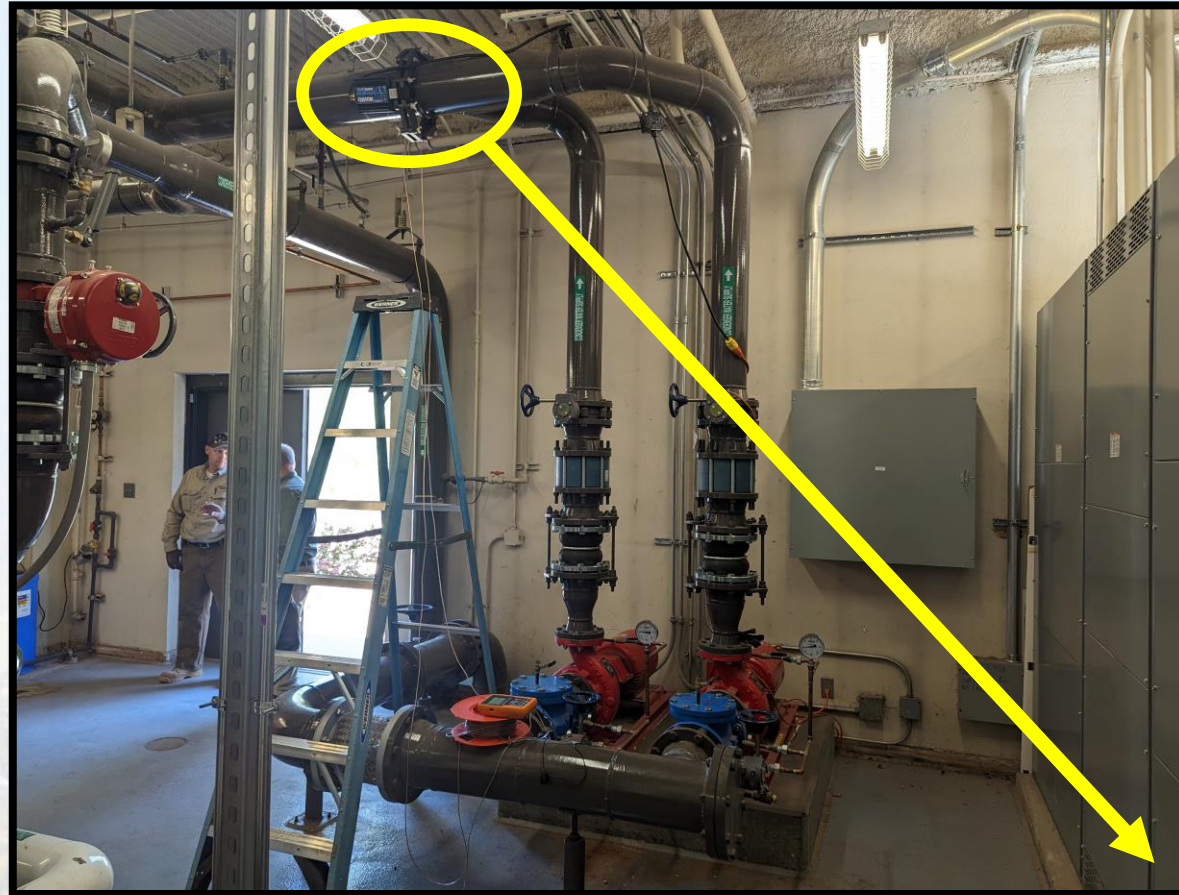
Installed *HydroFLOW* i8" Custom Unit

On May 1st, 2023, a *HydroFLOW* i8" Custom unit was installed on the condenser water line between the tower and chiller. Conductivity was increased from 3,000 $\mu\text{S}/\text{cm}$ to 7,000 $\mu\text{S}/\text{cm}$ and chemical usage was discontinued apart from small amounts of biocide.

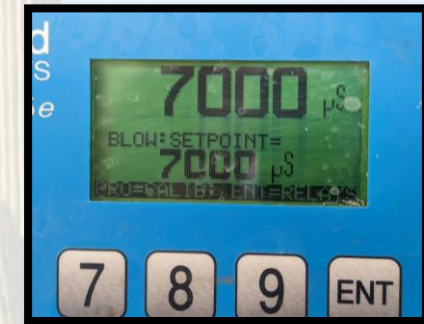
Conductivity meter at 7,000 $\mu\text{S}/\text{cm}$
